**Appendix A**

**Photographs Pertinent to TRA-63**

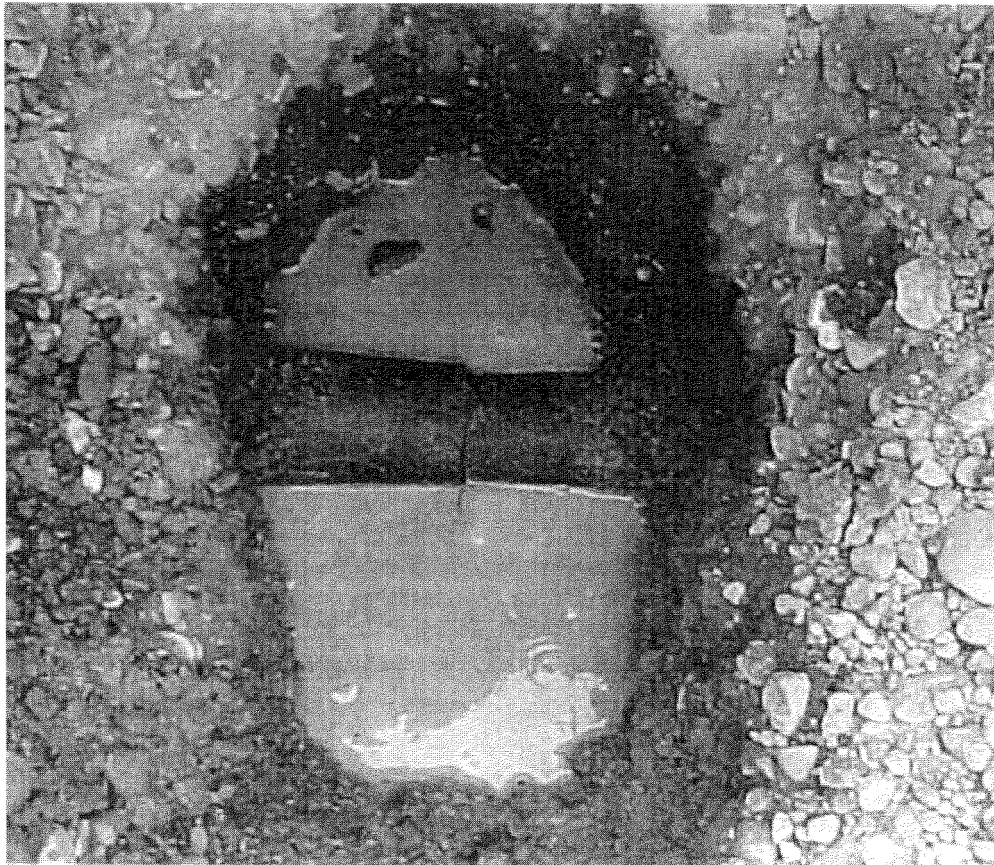
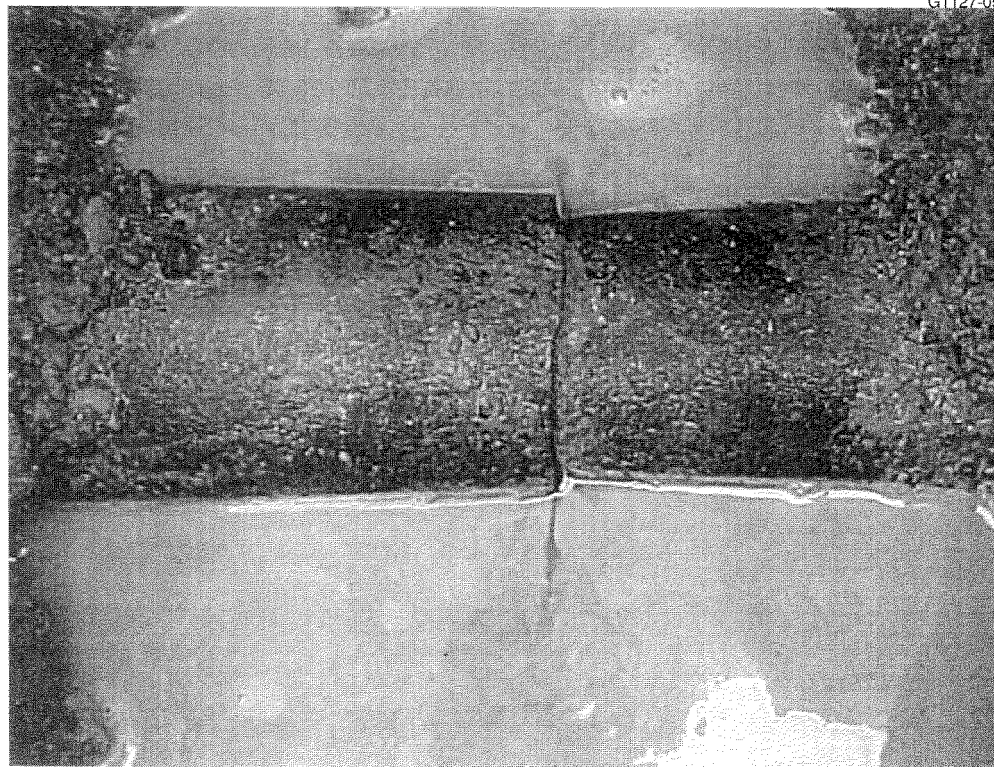
G1127-05

Figure A-1. A puddle of approximately 3 gal of radioactively contaminated water formed as soil was removed from the area around the 4-in. warm waste pipe.

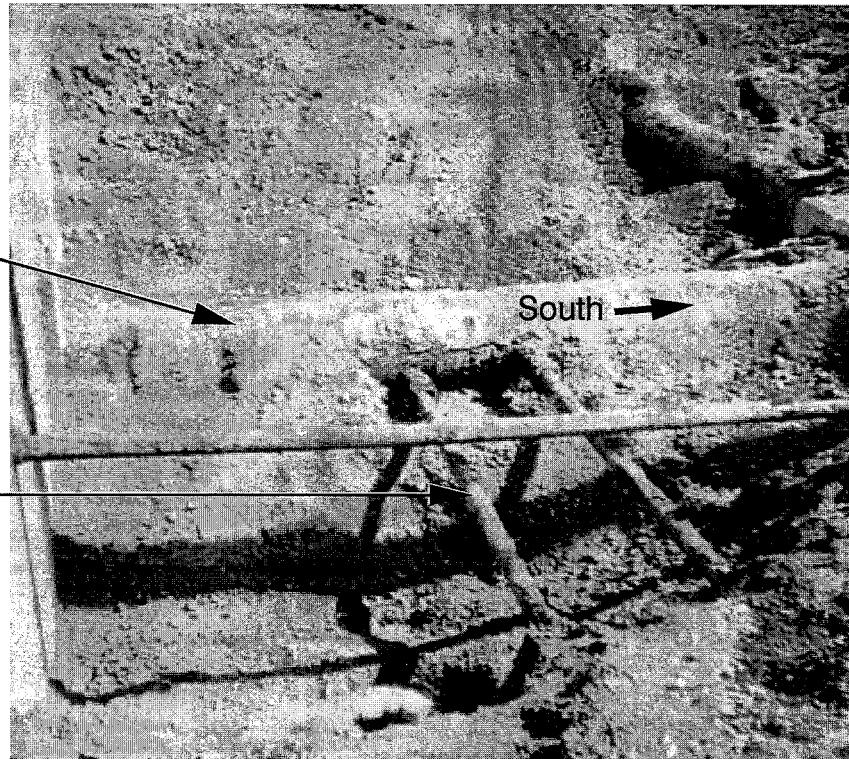
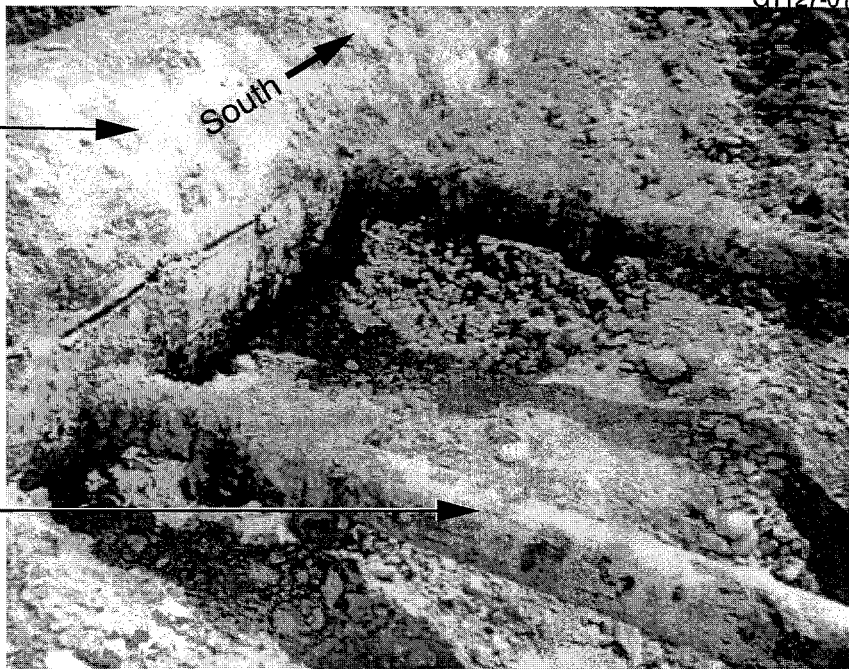
G1127-01

30-in. warm  
waste pipeline

4-in. warm  
waste pipeline  
(WDC-605)

Figure A-2. Photographs showing the 4-in. pipeline tie-in to the 30-in. pipeline during excavation for the 30-in. Warm Waste Pipeline Replacement Project.

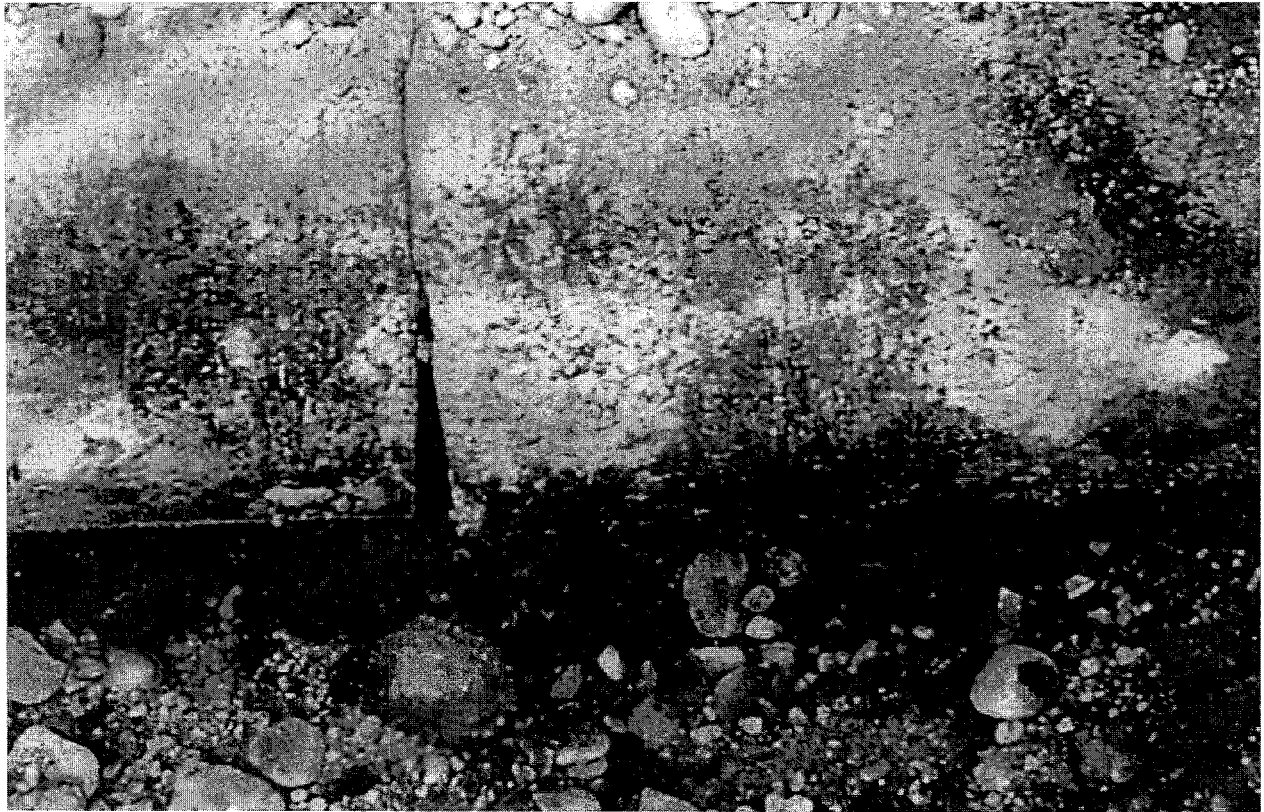
G1127-06

Figure A-3. Approximate 1/2-in. shear in the 4-in. pipe.

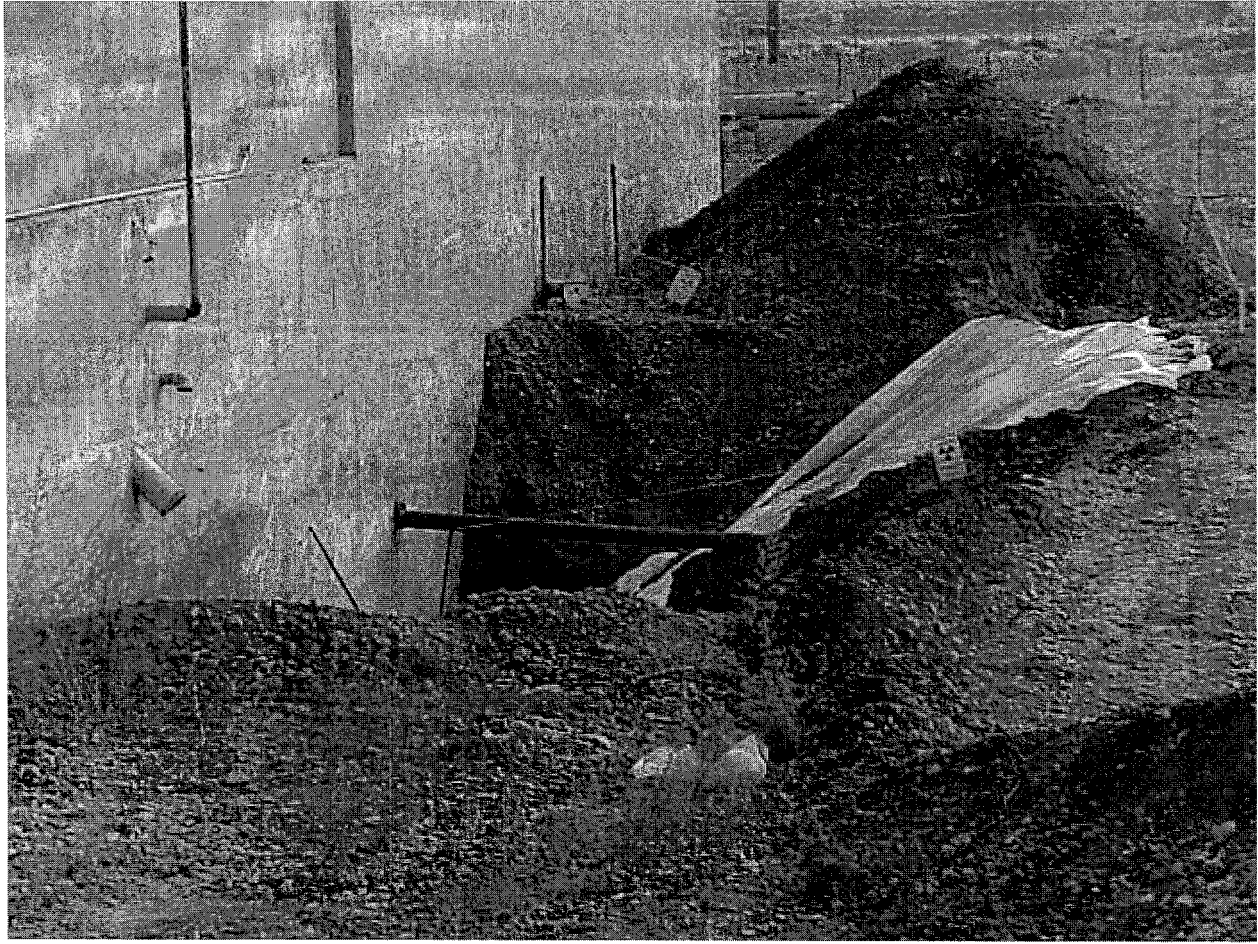
Figure A-4. Photograph of 4-in. pipeline during 30-in. Warm Waste Pipeline Replacement Project.
